ANGKOR VAT

INDIA'S CONTRIBUTION IN CONSERVATION

MEMOIRS OF THE
ARCHAEOLOGICAL SURVEY OF INDIA
NO. 91

B. NARASIMHAIAH

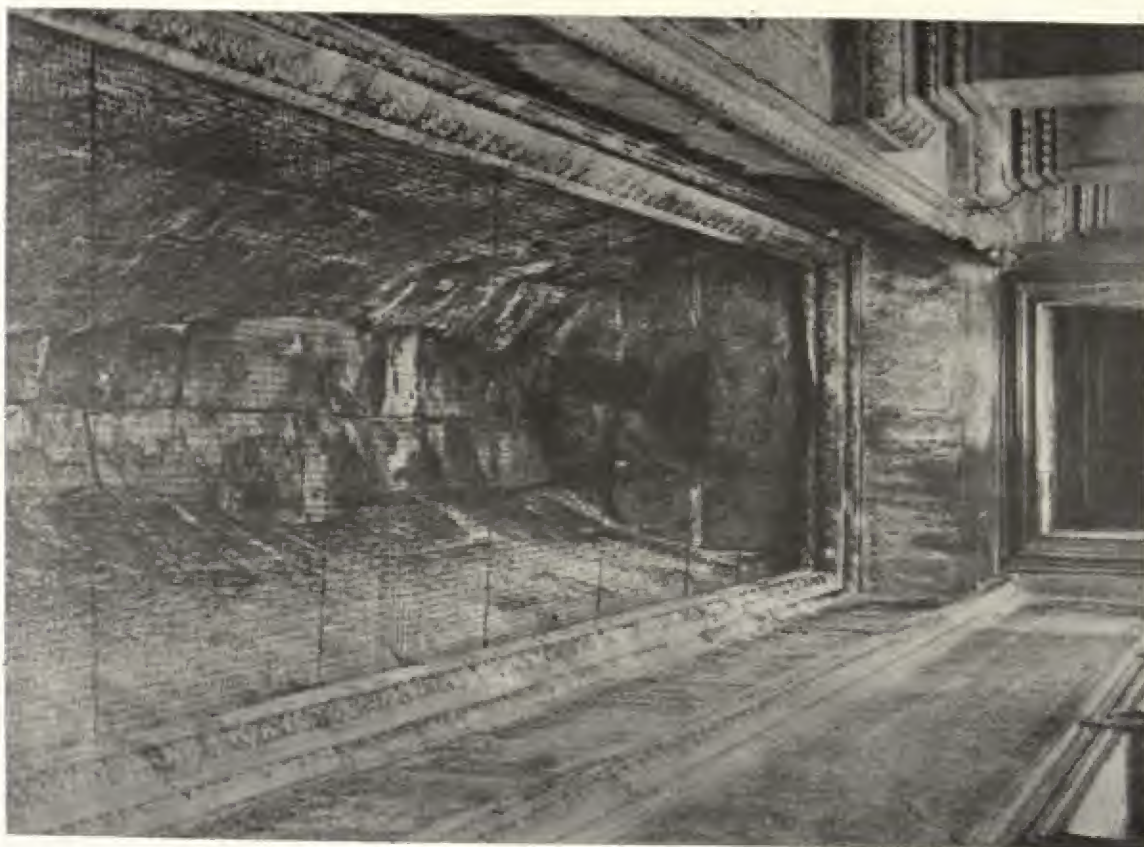
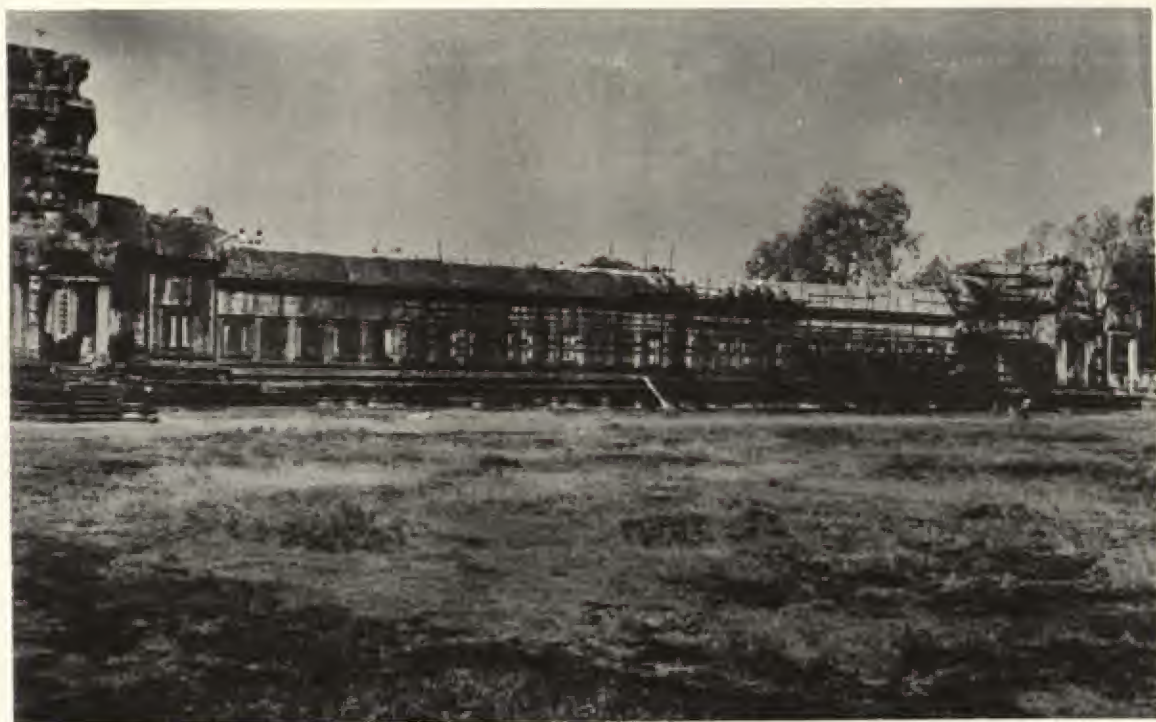
First Enclosure : galleries provided with welded mesh

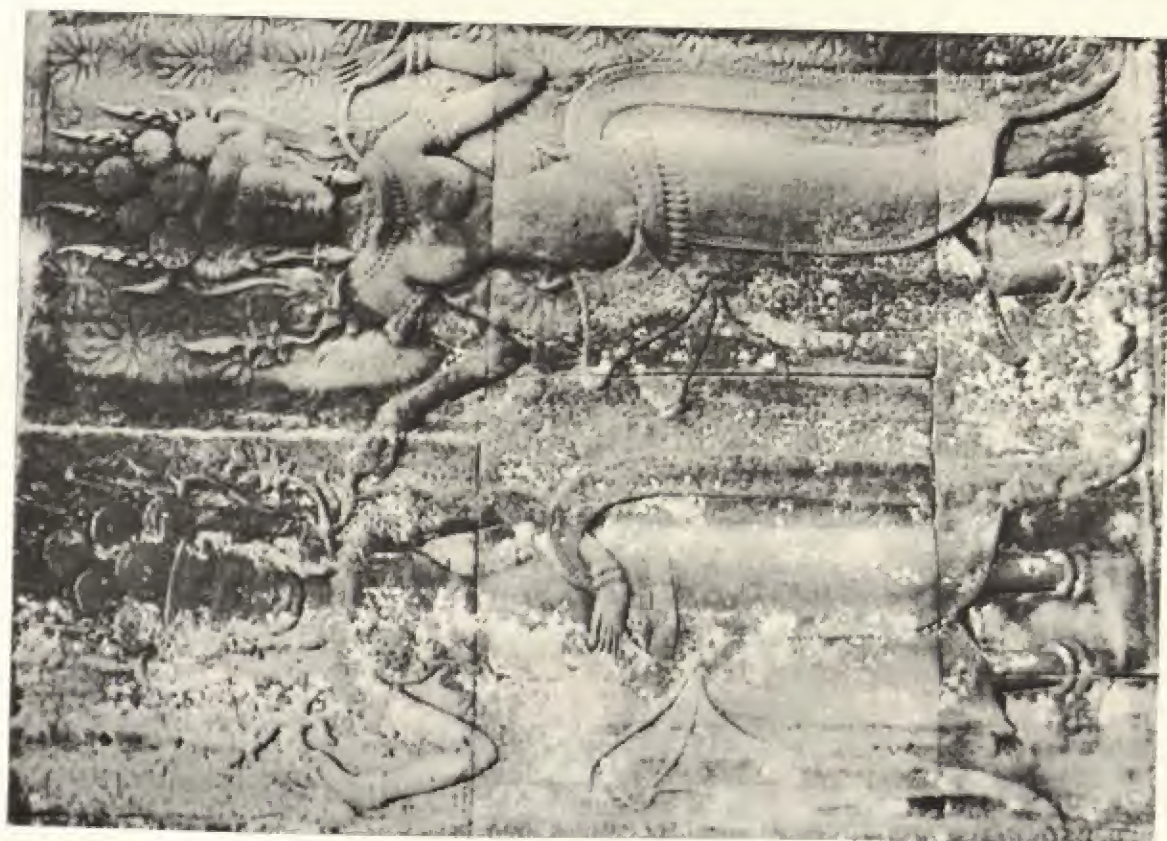
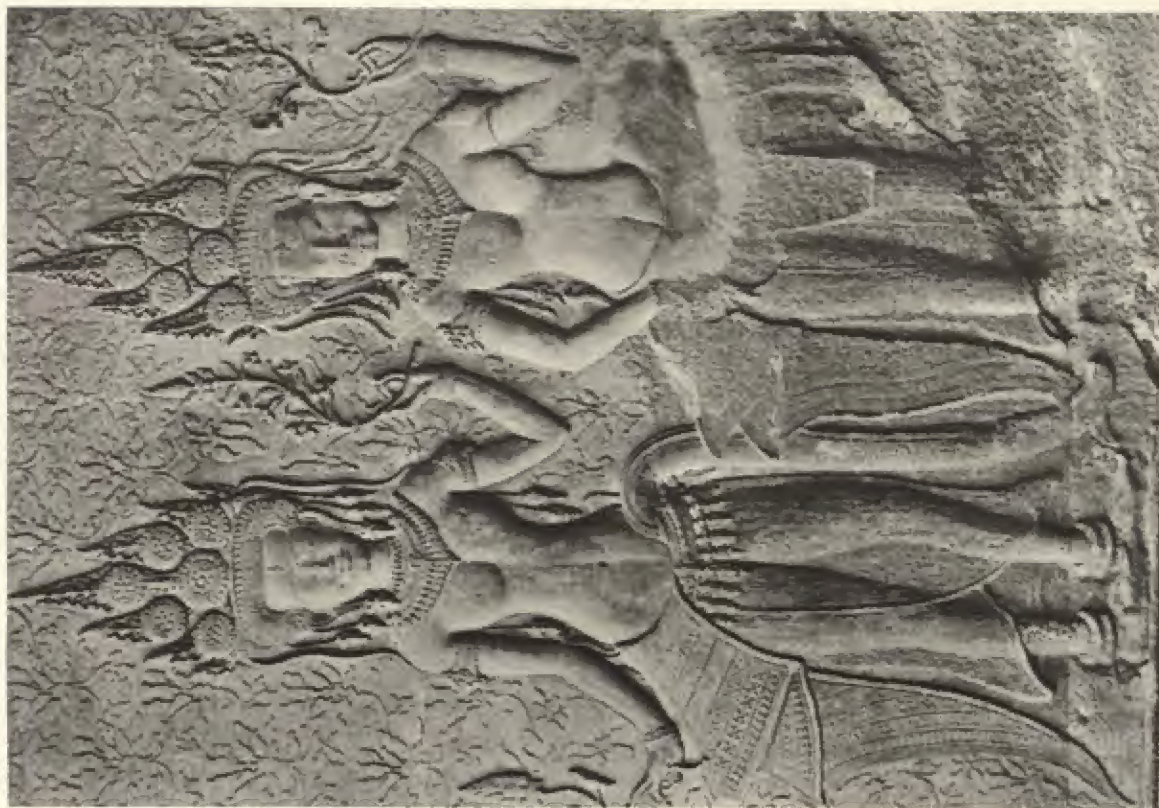
Fourth Enclosure : Western Gateway, apsaras, A, before and B, after chemical treatment

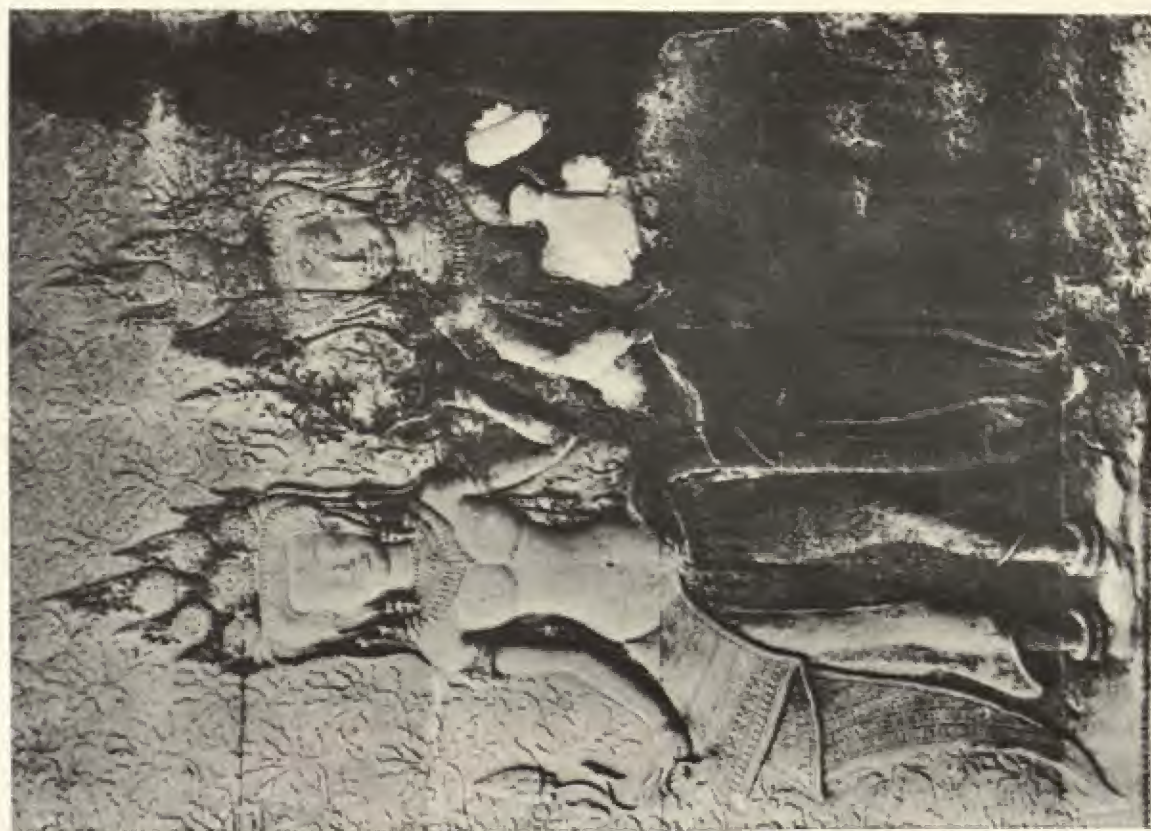
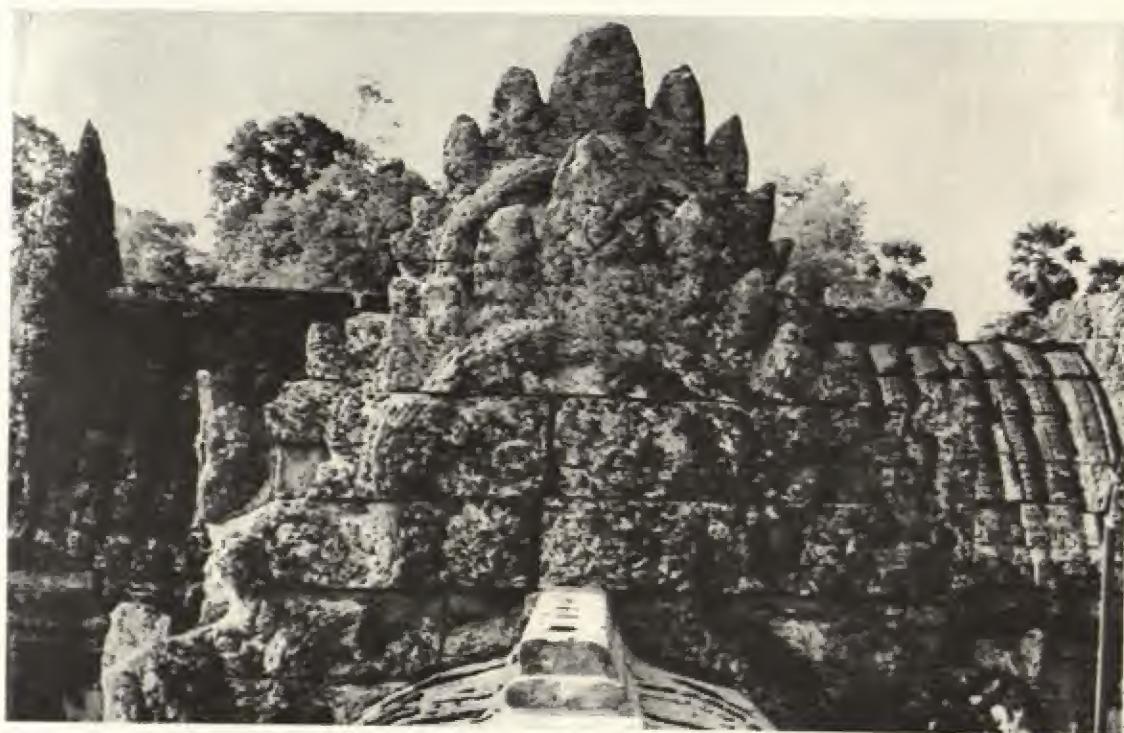
Fourth Enclosure : Western Gateway, apsaras, A, before and B, after chemical treatment

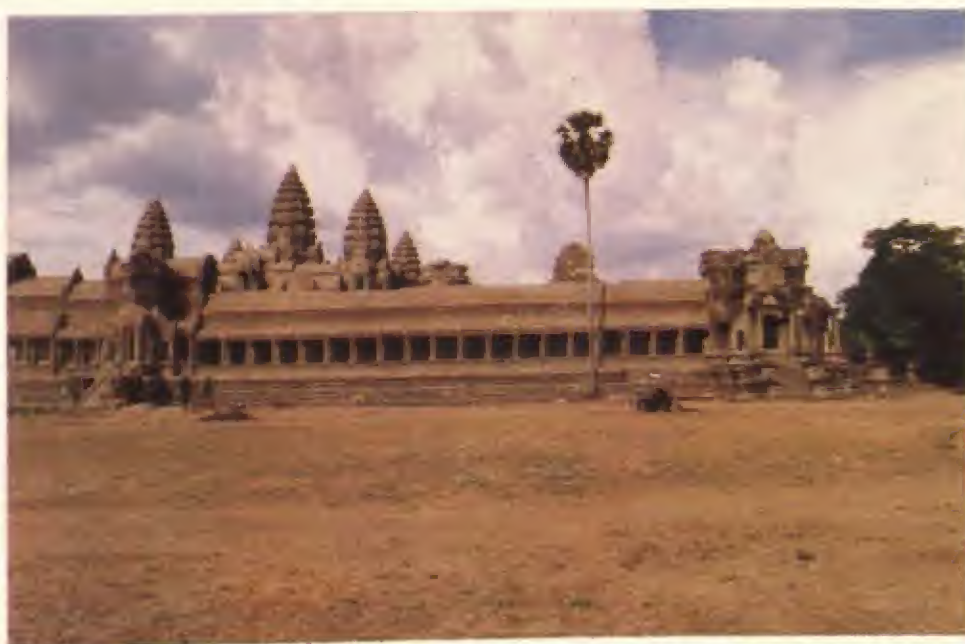
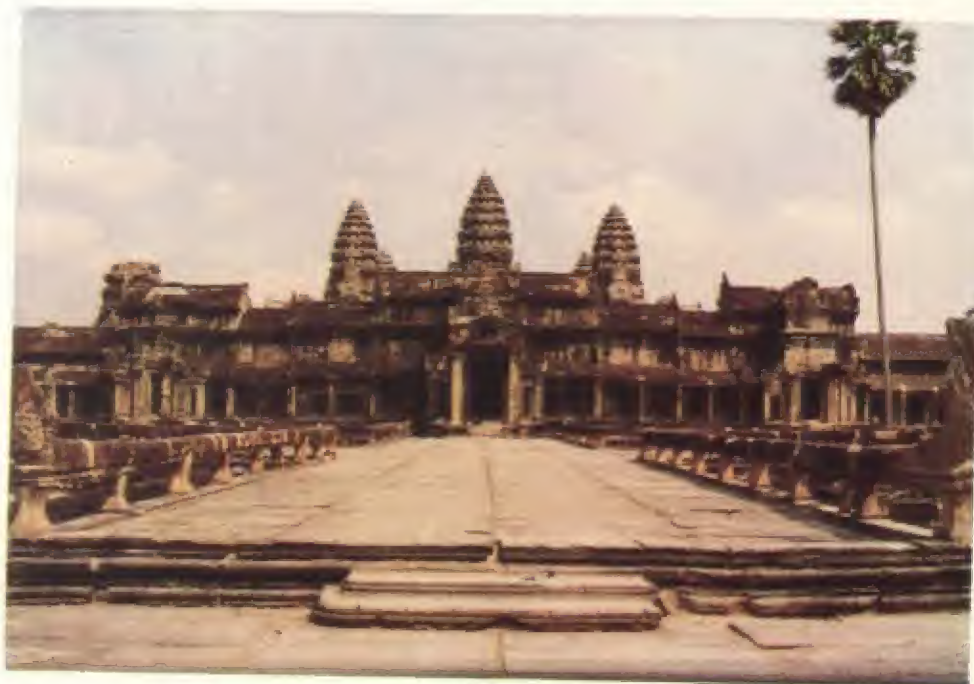
Third and First Enclosures ; towers and enclosures, A, before and B, after chemical treatment

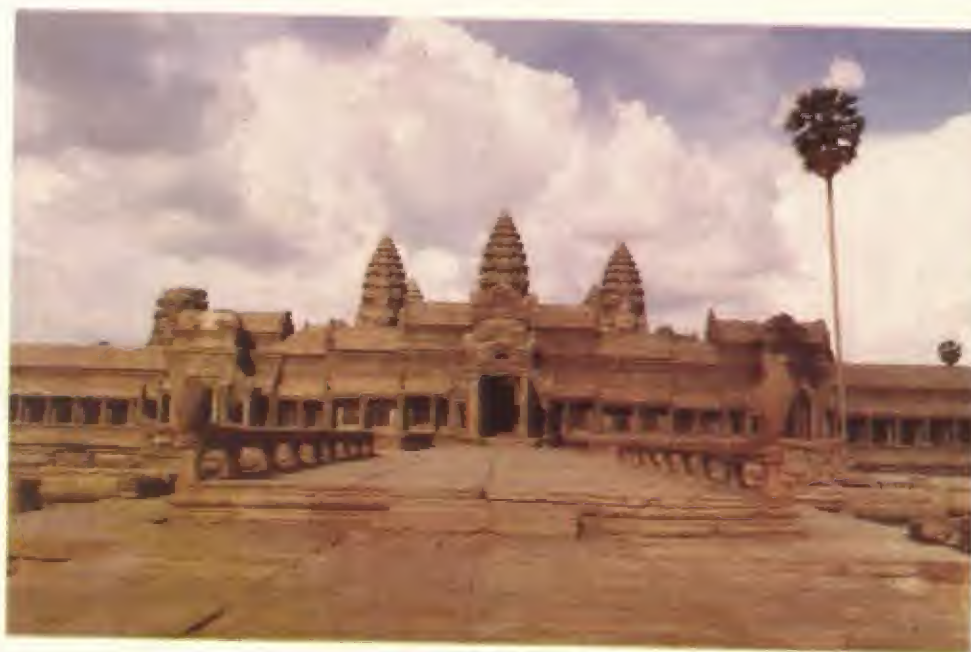
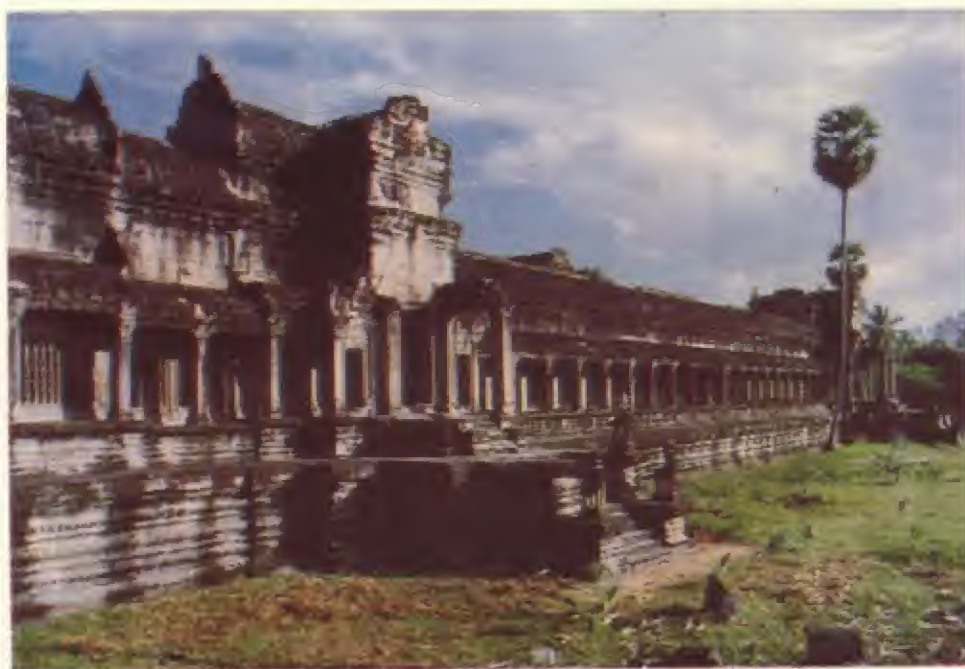
Esplanade and Third and First Enclosures, A, before and B, after chemical treatment

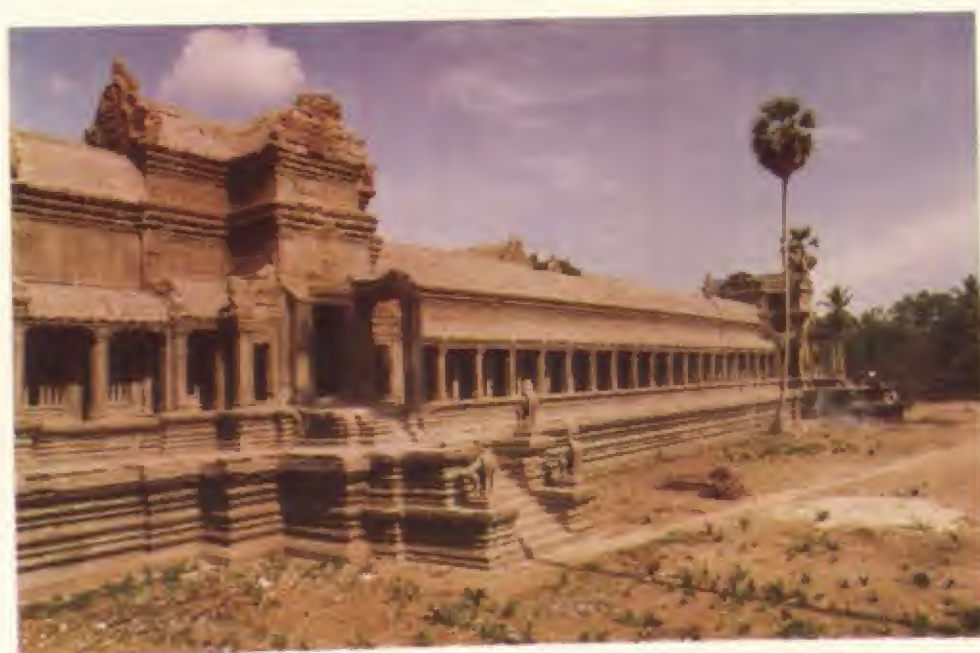
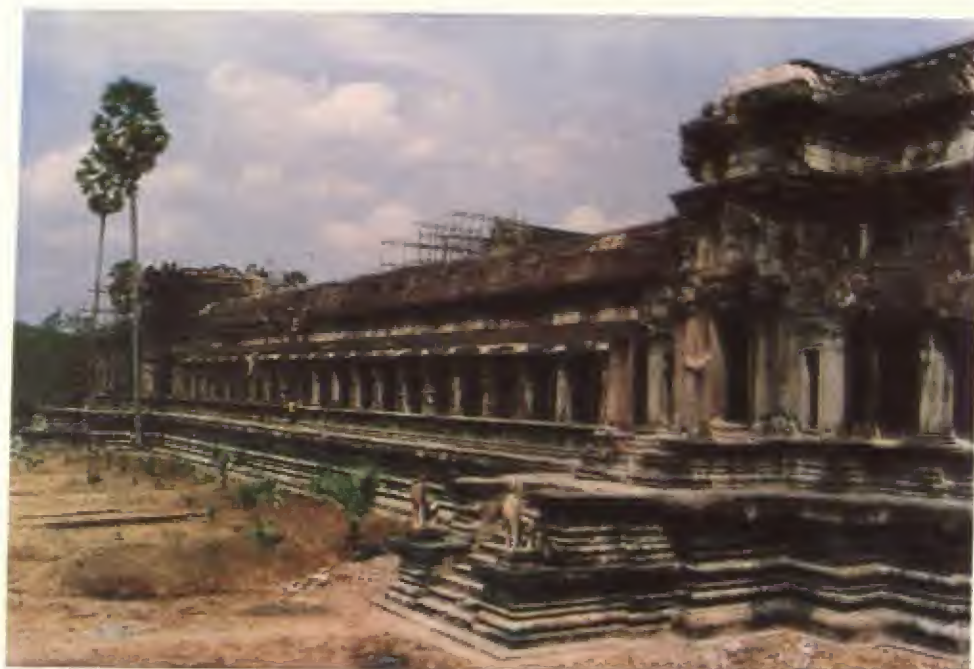
Third Enclosure : Southern Gallery on western side, A, before and B, after chemical treatment

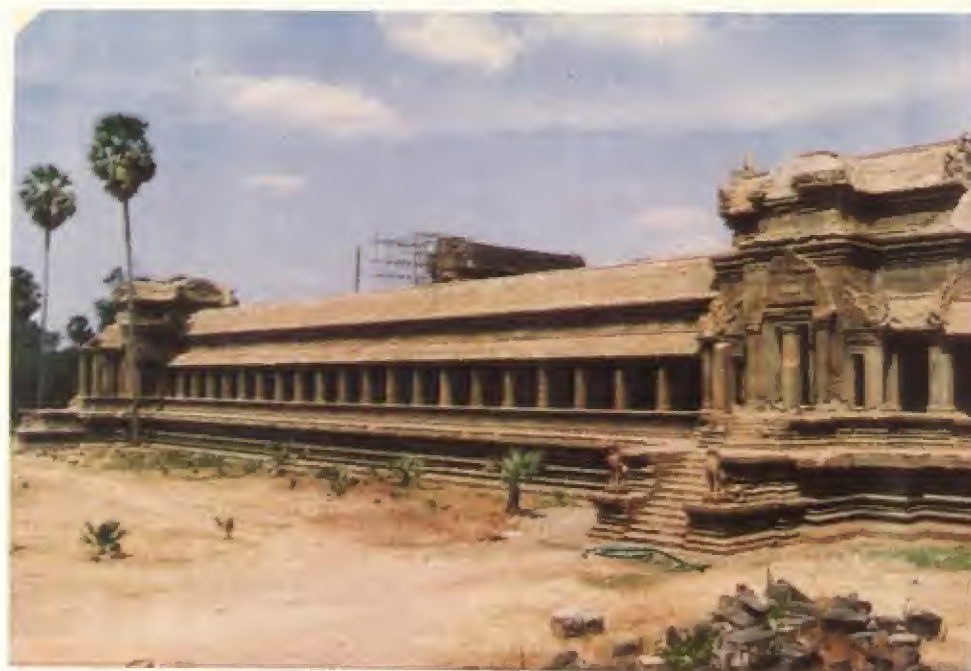
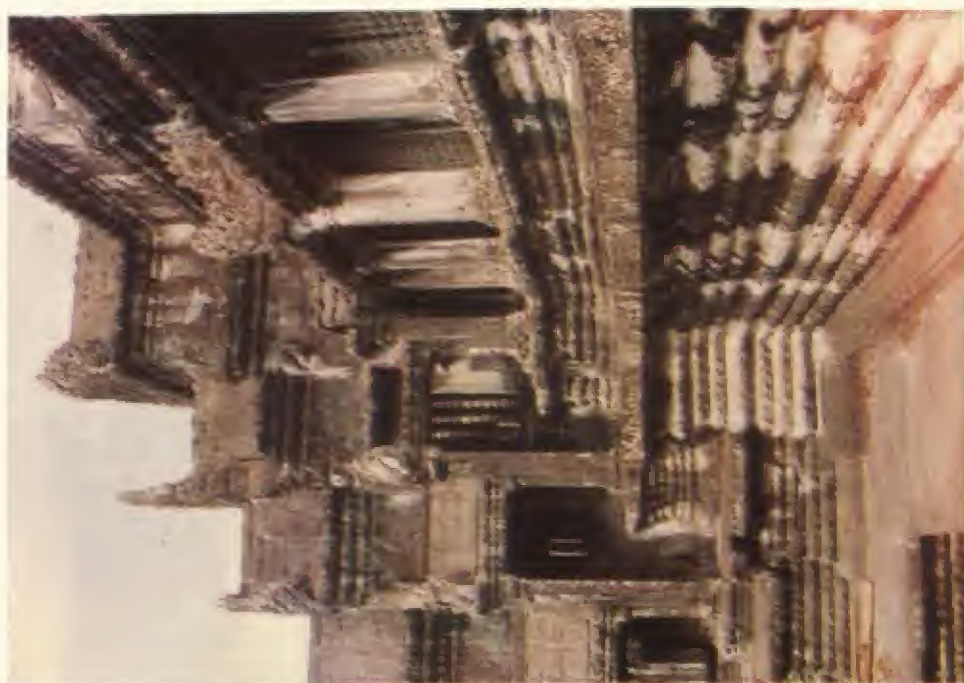
Third Enclosure : Northern Gallery on western side, A, before and B, after conservation and chemical treatment

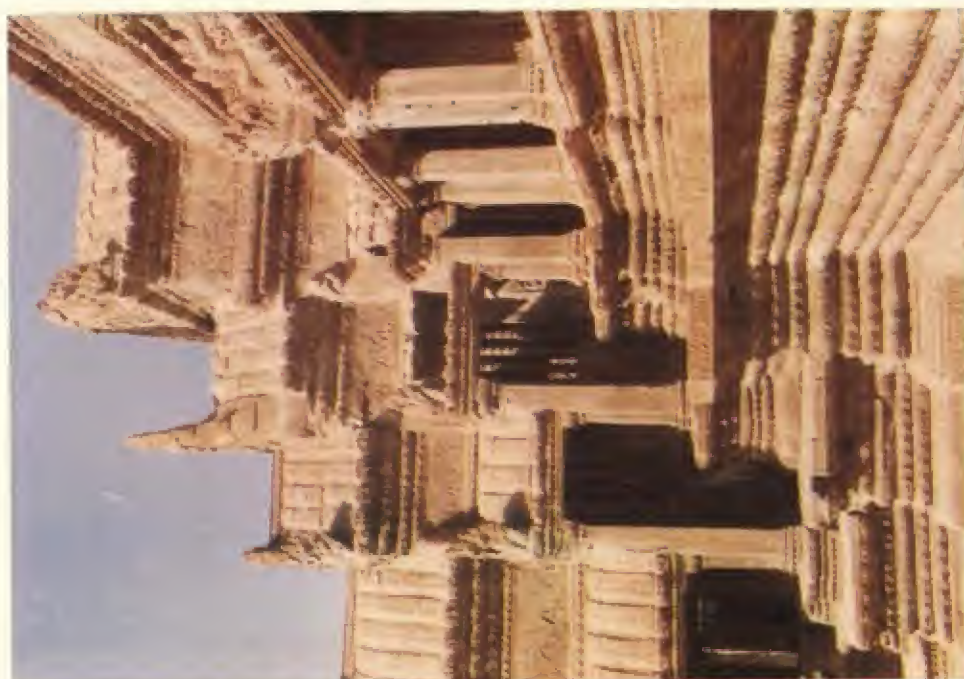
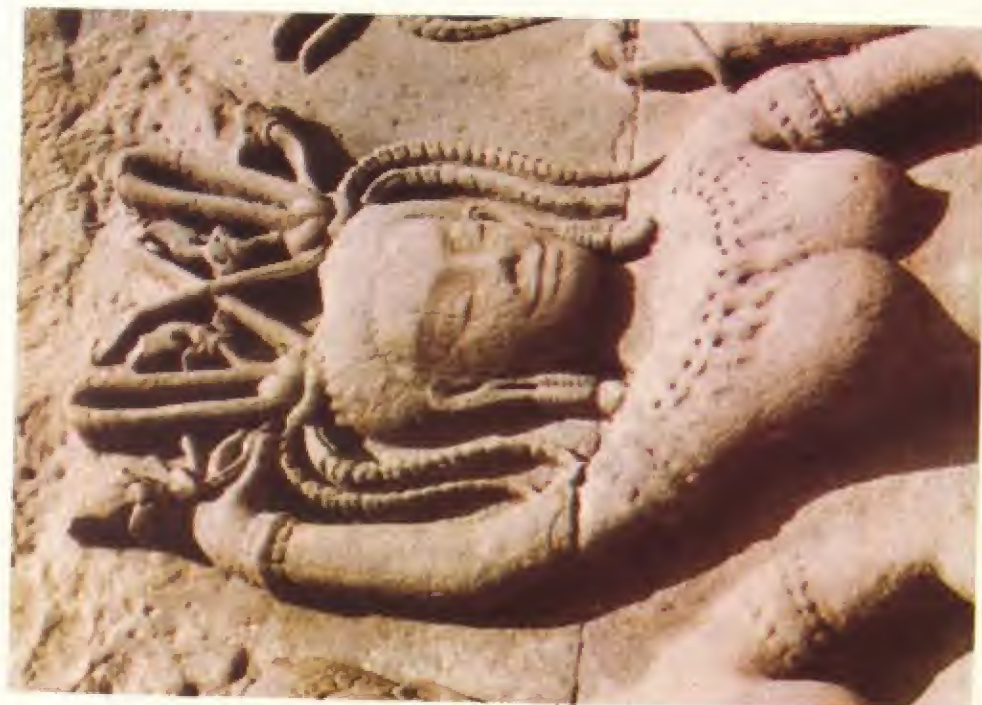
Antechamber : galleries, A, before and B, after chemical treatment

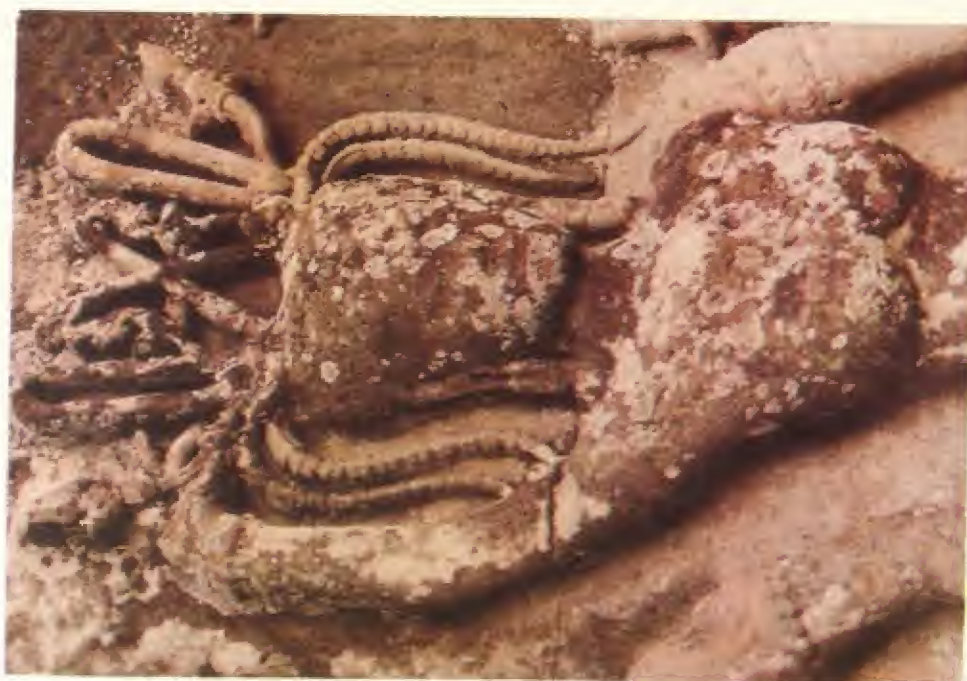
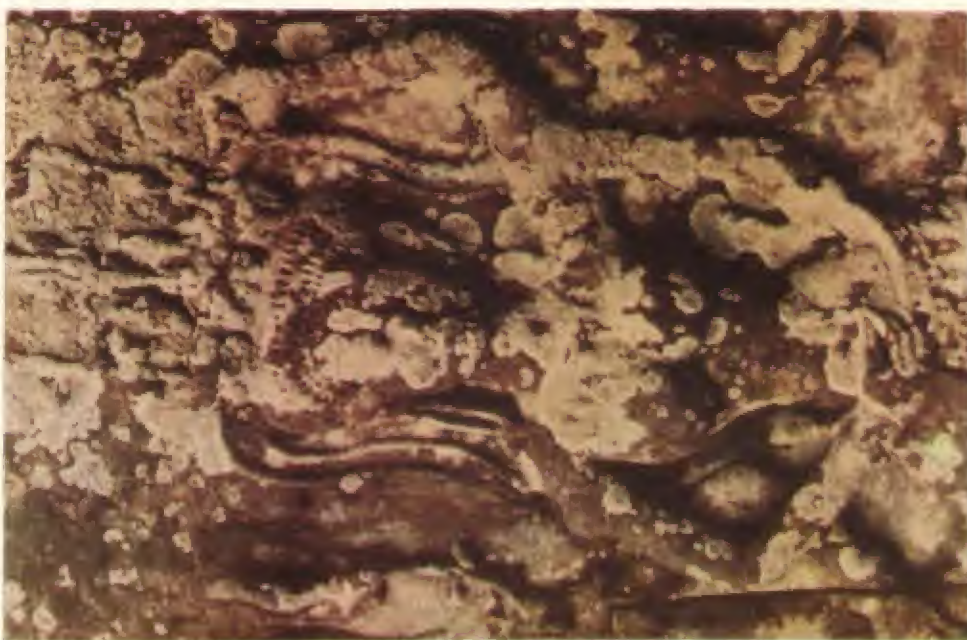
Second Enclosure : apsara, A, before and B, after chemical treatment

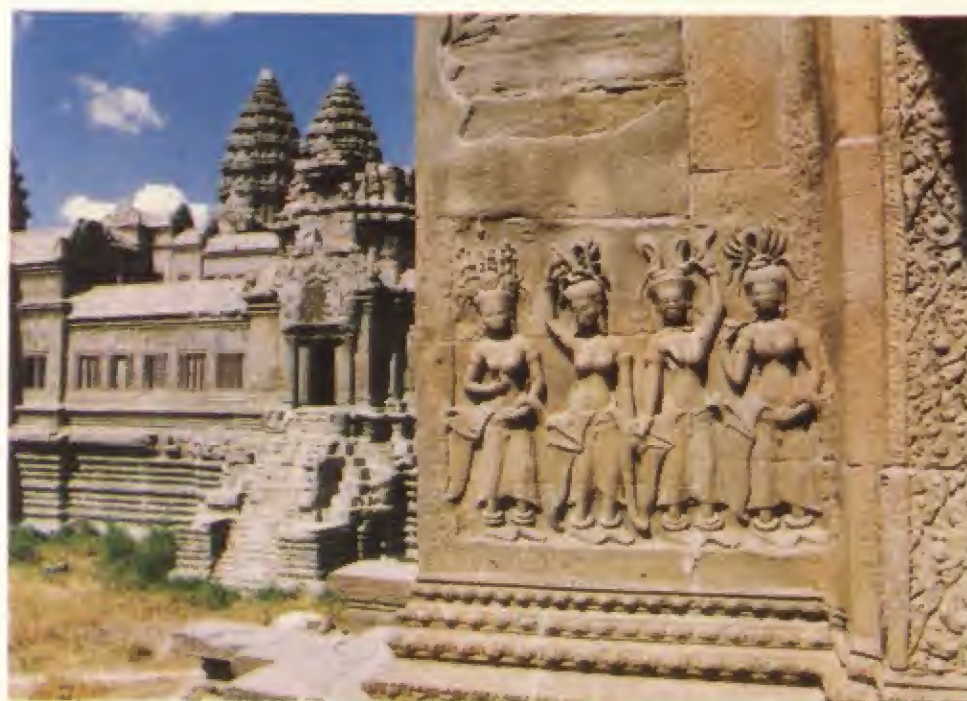
*Library between Second and Third Enclosures : apsaras, A, before and B, after
chemical treatment*
